Manhole Inspection Summary

Manhole # S21K__049MH

Insp Date: **4/3/08 8:41 AM**

Location Address: **1821 wilhelm st**

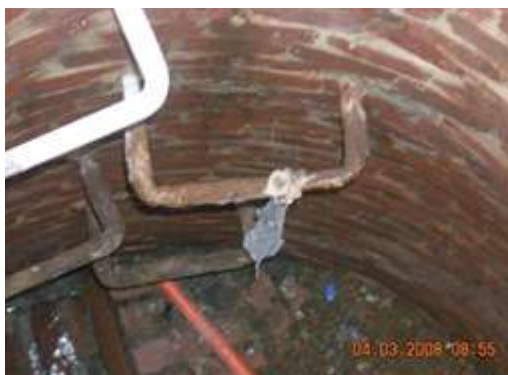
Defect 3

Surcharge ☒ **Evidence Of Surcharge** Depth: **5** (ft.) ☐ Active Surcharge Present

surcharge evidence

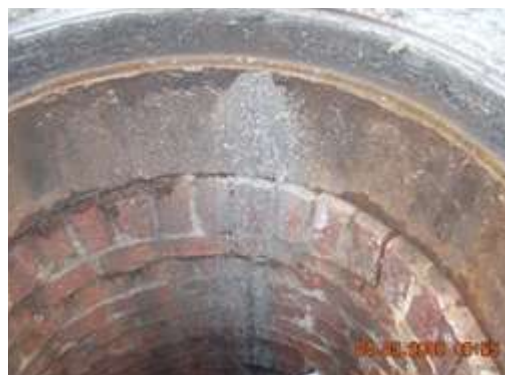
Defect 2

Infiltration: ☐ None ☒ **Joint** ☐ Cracks ☐ Mortar ☐ Roots ☐ Wall

infiltration @ chimney/frame joint

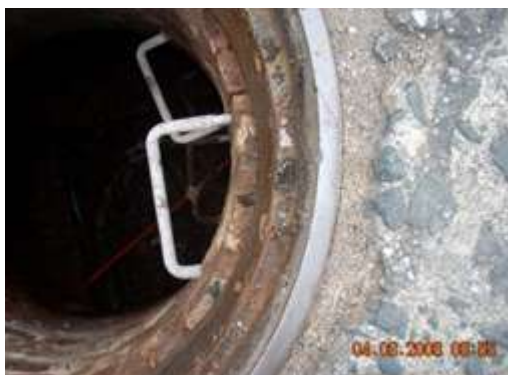
Defect 1

Frame Offset: **1** (in.) Condition: ☒ Sound ☐ Cracked ☐ Leaks

frame offset

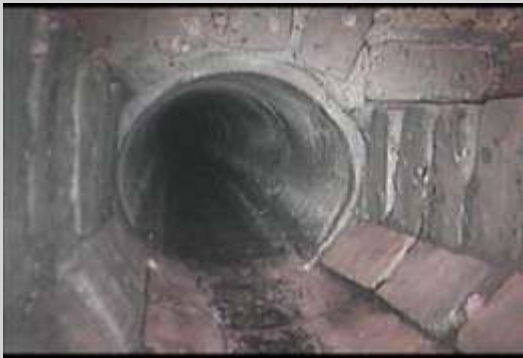
12 O'Clock Outflow

8 in. Circular Gravity Sewer
Pipe Out @ 12 O'Clock

Pipe Height: **7.2** (in.) Rod and Bar (Angled)
Pipe Material: **Clay** ☐ Pipe Lined
Invert Depth: **8.53** (ft.) Flow Characteristics: **Slow**
Deposits: ☒ None ☐ Mud ☐ Sludge ☐ Debris ☐ Grease
Silt Depth: **0** (in.) Deposits Extent:
Infiltration: **None** Pipe Seal Cond: **Sound**

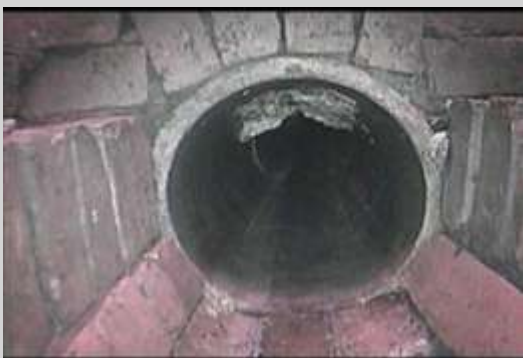
9 O'Clock Inflow

8 in. Circular Gravity Sewer
Pipe In @ 9 O'Clock

Pipe Height: **8.4** (in.) Rod and Bar (Angled)
Pipe Material: **Clay** ☐ Pipe Lined
Invert Depth: **8.20** (ft.) Flow Characteristics: **Slow**
Deposits: ☒ None ☐ Mud ☐ Sludge ☐ Debris ☐ Grease
Silt Depth: **0** (in.) Deposits Extent:
Infiltration: **None** Pipe Seal Cond: **Sound**
